COLLINS COMPANY UPPER DAM CT 00674

PHASE I INSPECTION REPORT NATIONAL DAM INSPECTION PROGRAM

JULY, 1979

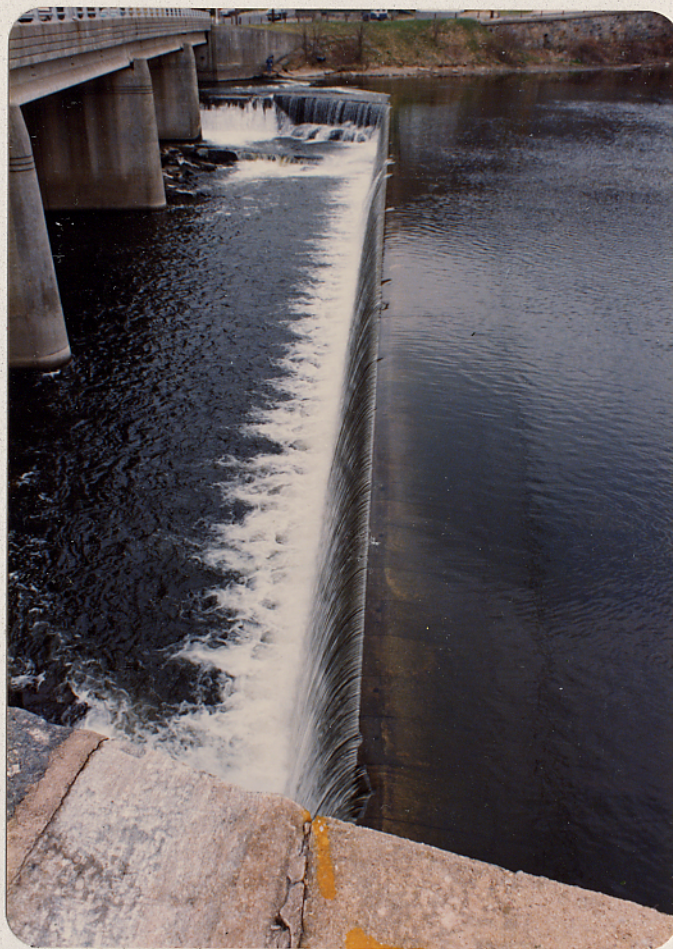
Main Dam Masonry Spillway - The masonry section of the dam, at elevation 286.2, constitutes the main spillway, and is approximately 325 feet long, varying from between 6 and 18 feet high (Photo 1). Generally, it appears to be in good condition with no evidence of vertical or lateral displacement of the precisely cut granite gneiss blocks. No seepage through the masonry was observed, however, a clear observation of the downstream face and toe was prevented by water flowing over the crest.

The spillway is capped by what appear to be granite blocks which are 11.3 feet across and which slope down to the upstream side on an approximate three horizontal to one vertical inclination (Photo 1). Near the downstream edge of the caps are drill holes used for the installation of posts for flashboards. The cap of the spillway appears to be in good condition with only a few places where pieces of the blocks have chipped away.

PHOTO 1 - General view of masonry main dam spillway from right end of earthen embankment (April, 1979).

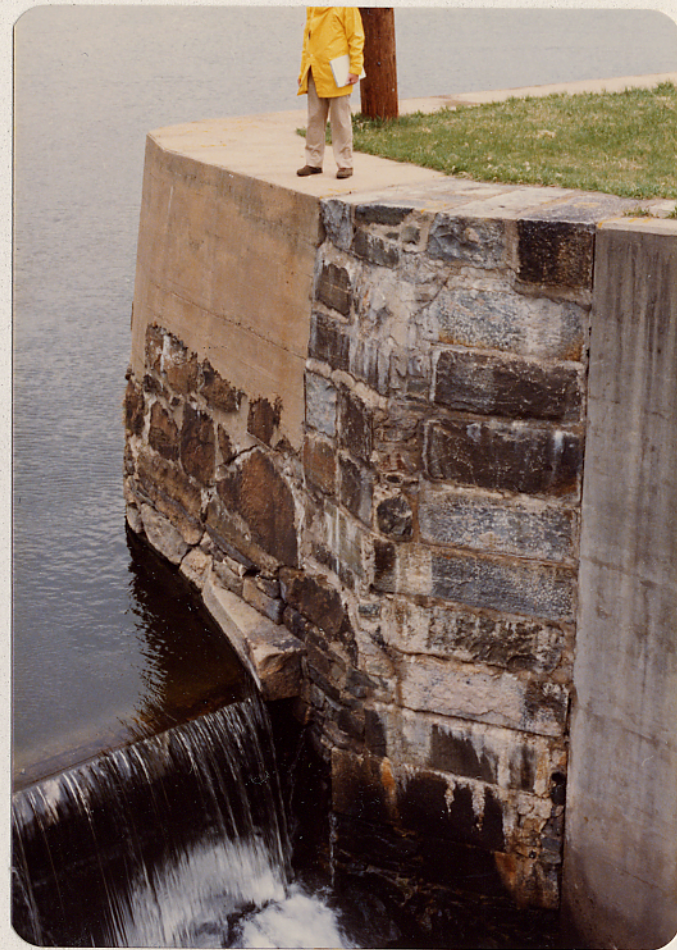
PHOTO 2 - Abutment of main dam spillway with embankment retaining wall. Note minor seeps in wall approximately one and three feet downstream of spillway crest (April, 1979).

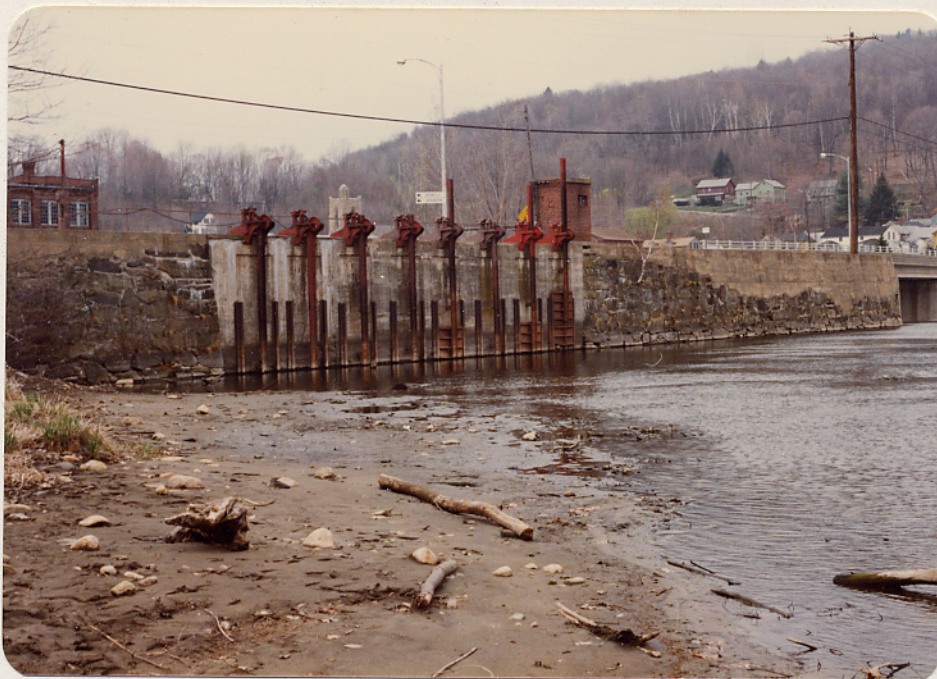
PHOTO 3 - Upstream view of earthen embankment and eight sluice gates at left end of main dam (April, 1979).

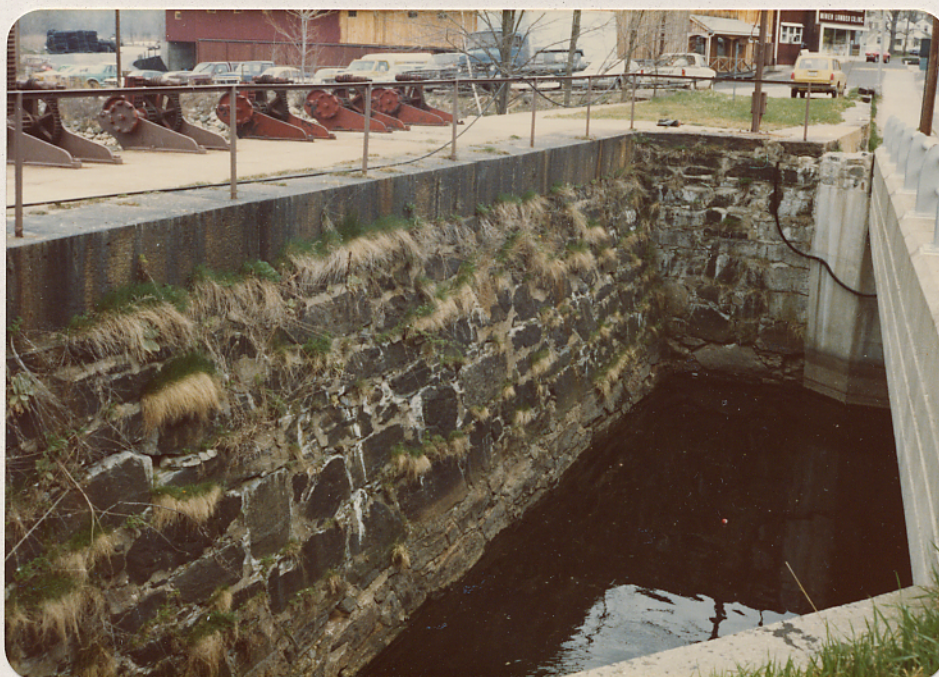
PHOTO 4 - Downstream masonry headwall for sluice gates at inlet to forebay (April, 1979).

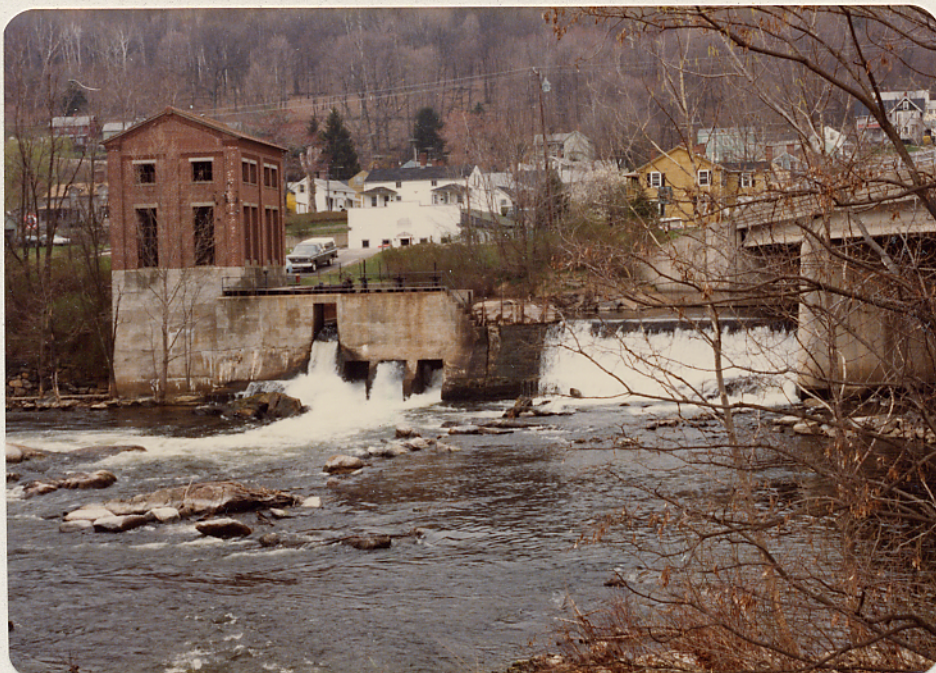
Concrete Wing Dam - The concrete wing dam extends downstream perpendicular to the major portion of the main spillway for 200 feet, where it adjoins the powerhouse (Photo 5). The 160 foot long broadcrested spillway is of trapezoidal cross-section and is at an elevation one foot lower than the main spillway. Flashboards may be accommodated along the length of the spillway crest. At the time of our inspection, only one approximately ten foot section of the flashboards at the right end of the spillway was intact, the rest having been broken away probably by ice in the winter and by spring flows (Photo 8). The abutment of the wing dam with the main spillway consists of a triangular shaped concrete section. The right abutment of the wing dam is 40 feet long and contains one mid level and three low level outlets. The concrete of the spillway portion is heavily spalled, while the right abutment is less so, except at the gate outlets where it is heavily spalled and some reinforcing is exposed. There is one extensive vertical crack at the joint between the spillway and the right abutment, however no seepage was observed at this crack.

Powerhouse - The presently non-functional powerhouse consists of a brick superstructure atop a concrete substructure, which appears to be founded on bedrock (Photos 5 & 6). Structurally, the powerhouse appears to be in good condition, with no significant cracking of the brick walls or concrete foundation and only minor spalling, however, it has been vandalized with only the easily accessible windows boarded up.

PHOTO 5 - Concrete wing dam and powerhouse at right end of dam.
Note missing flashboards (April, 1979).

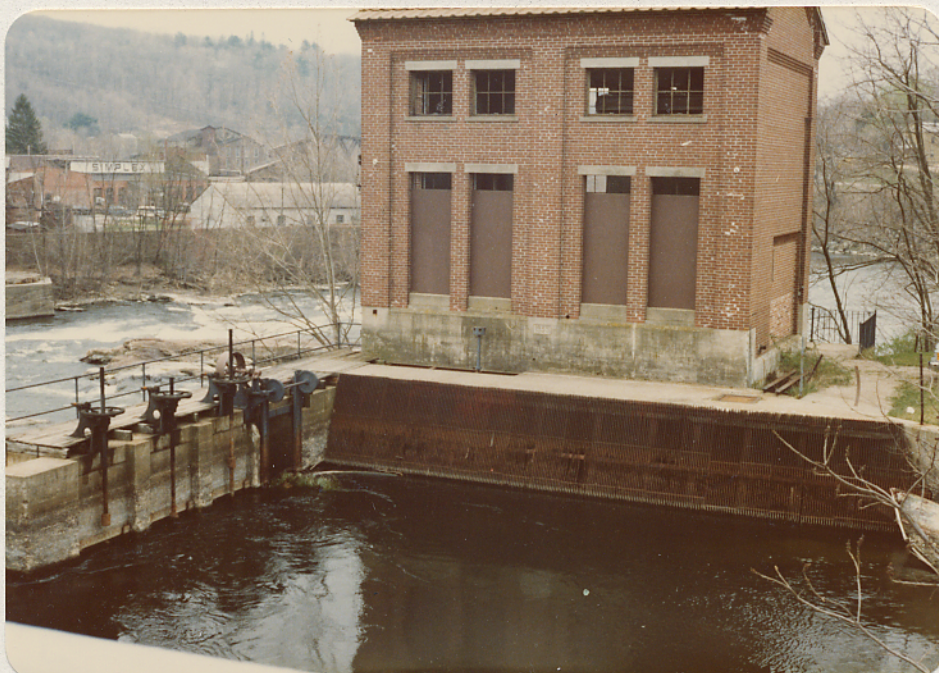
4. The valve stem to the left low level outlet in the wing dam abutment is disconnected, rendering it inoperable.
5. The birch tree growing from the upstream masonry retaining wall of the earthen embankment could eventually cause displacement of some of the masonry.

PHOTO 6 - Low level gate valves and trash racks at turbine intake.
Note disconnected stem of left gate valve and corrosion
of trash racks (April, 1979).

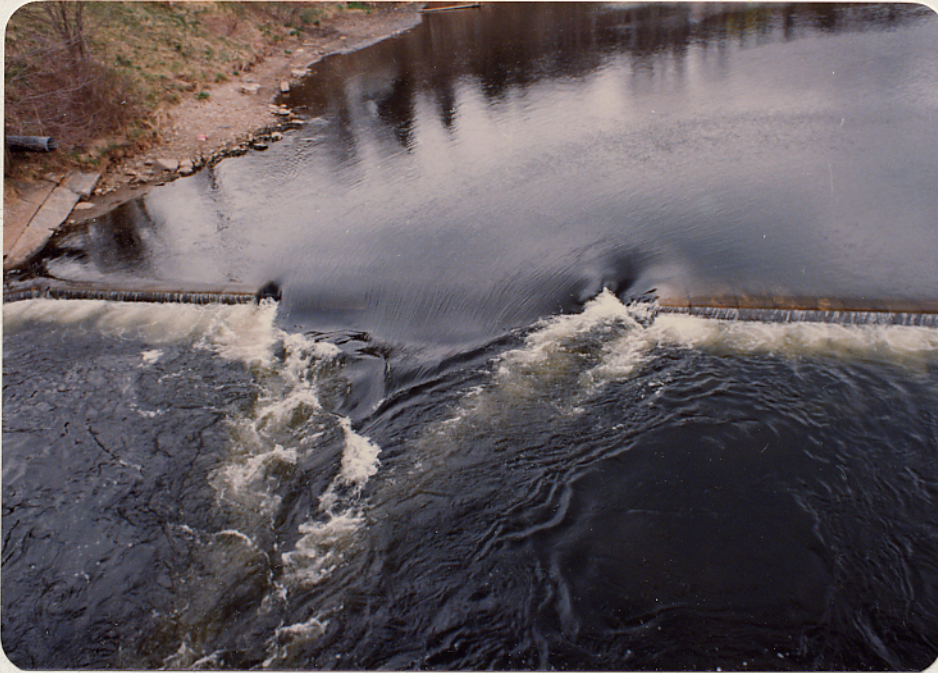
PHOTO 7 - Notch in main spillway at inlet to powerhouse intake channel contained by wing dam (April, 1979).

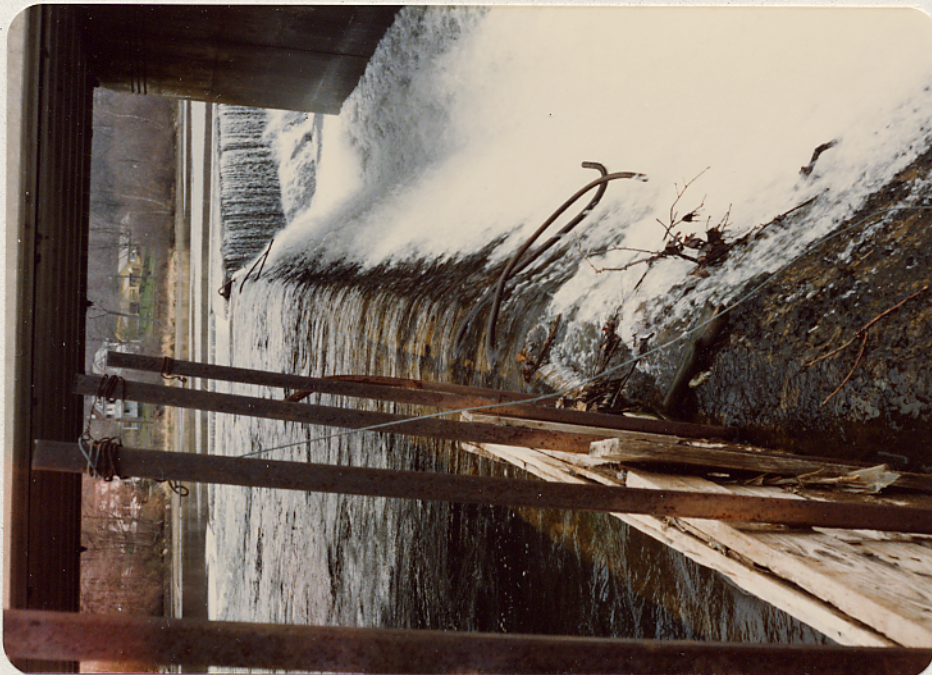
PHOTO 8 - Spillway crest of wing dam looking upstream from right wing dam abutment. Note broken flashboards (April, 1979).

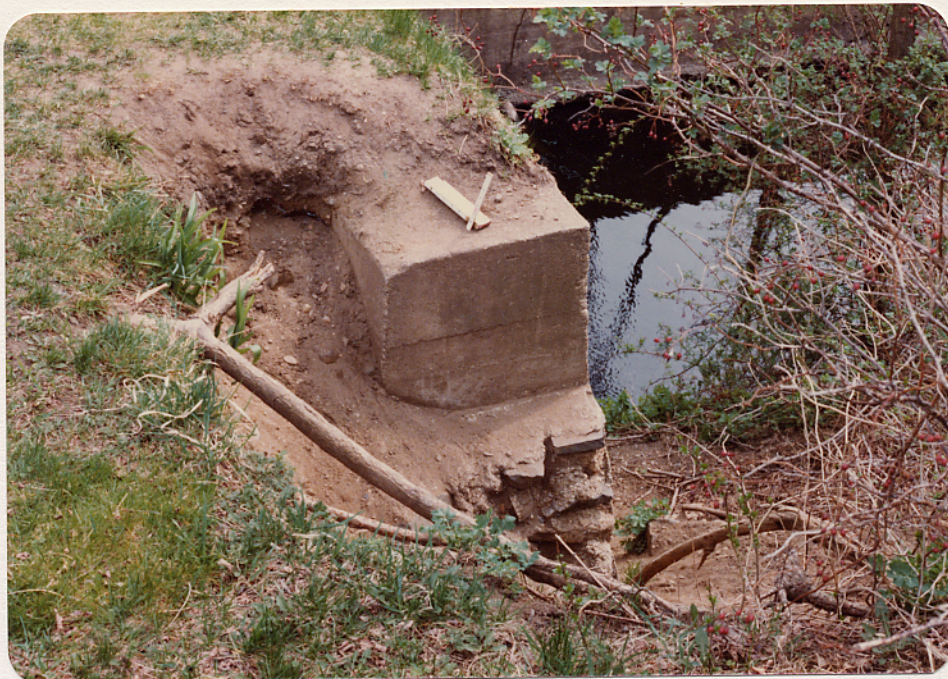
Discharge from the powerhouse is into a tailrace channel bounded on the left by a low concrete training wall (Photo 10) and on the right by a dry laid stone retaining wall and riverbank. The training wall is in poor condition, exhibiting cracking and undermining. Approximately 15 feet from the downstream end, a deteriorated portion of the wall allows water from the main channel to flow into the tailrace. The right retaining wall is in fair condition with minor seeps about 15 and 25 feet downstream of the powerhouse. Erosion is occurring at a footpath where the stone retaining wall meets the concrete substructure of the powerhouse (Photo 9).

PHOTO 9 - Erosion at right powerhouse abutment (April, 1979).

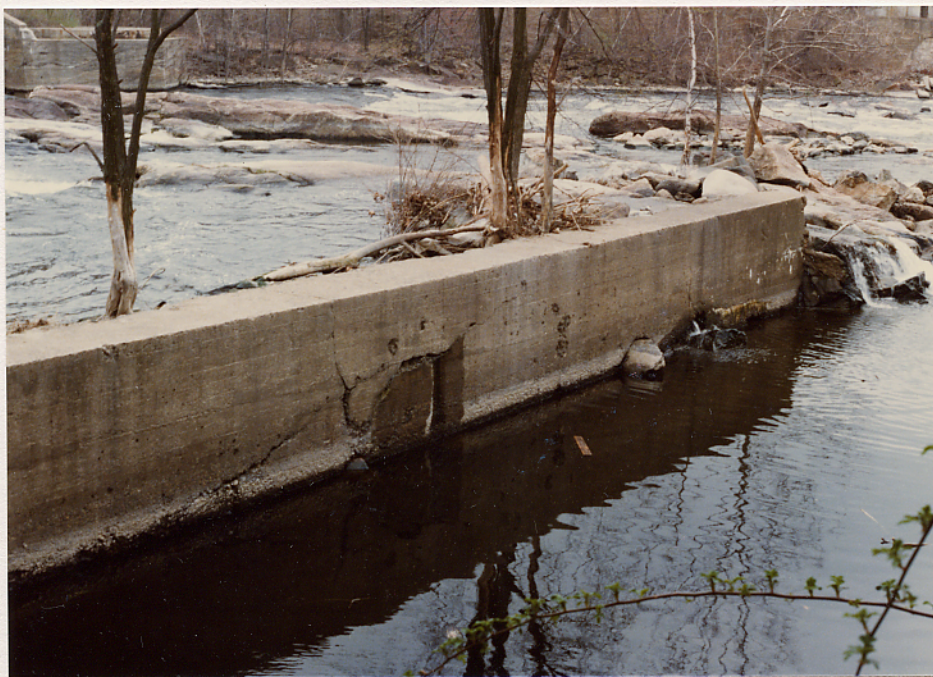
PHOTO 10 - Concrete tailrace training wall. Note cracking and deterioration of concrete (April, 1979).

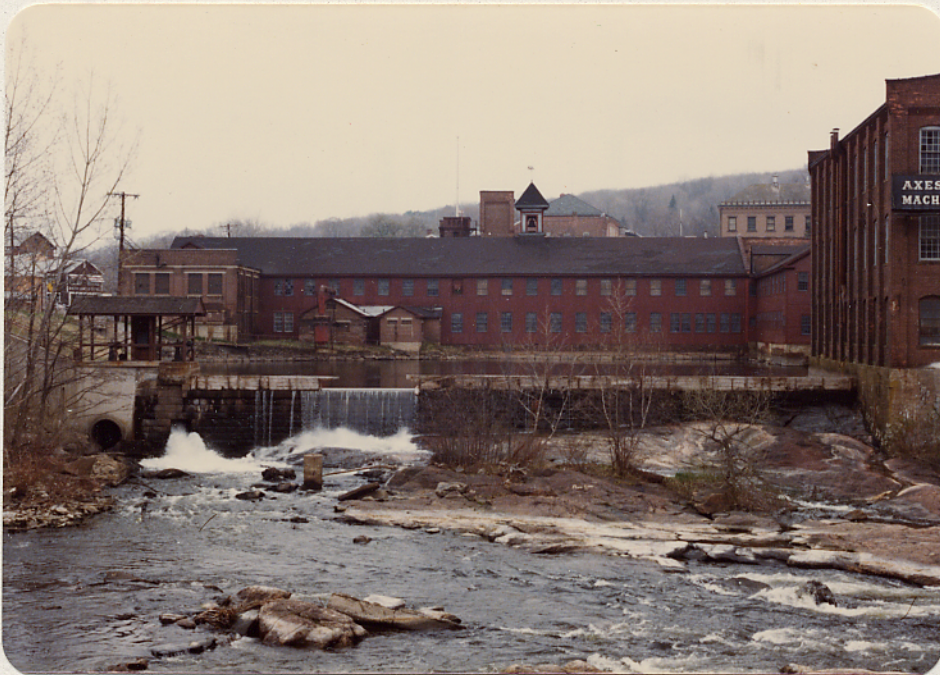
Masonry Forebay Dam - The mill forebay is retained by a masonry dam on bedrock which extends from the highway abutment to the mill buildings (Photos 11, 13 and 14). Flashboards, broken in several places, top the dam. The dam appears in good condition with the exception of one possible leak at a 3/8 inch joint about 25 feet from the left abutment and about 2 feet from the crest (Photo 12). The water may, however, be water which passes over the crest, collects in a depression between the upper two courses of stonework and exits through a partially open joint.

PHOTO 11 - General view of masonry dam for mill forebay. Note section of broken flashboards and low level outlets. Route 179 is at left (April, 1979).

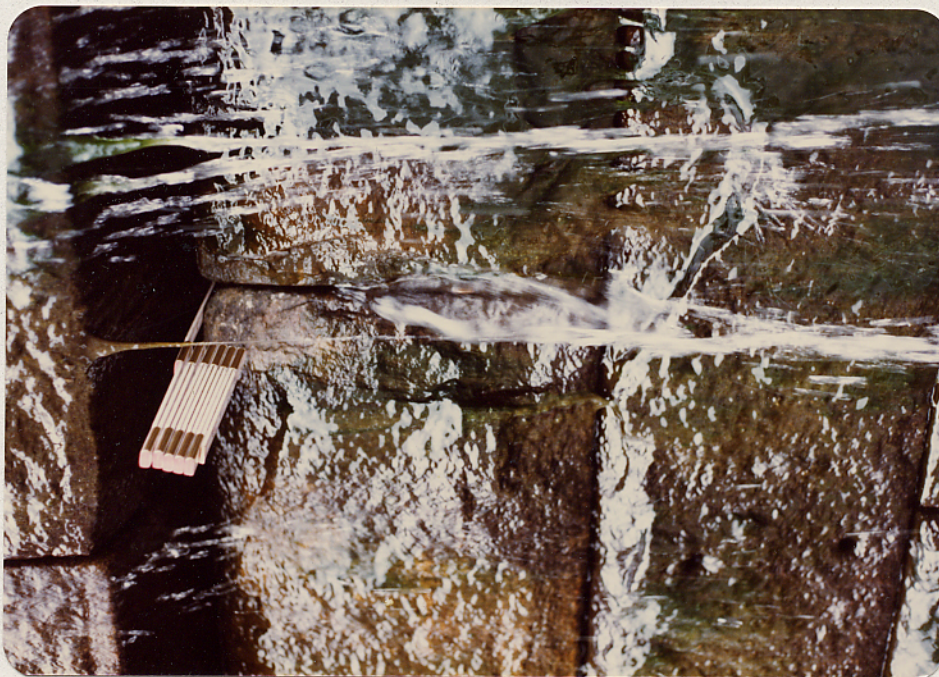
PHOTO 12 - Possible seep in forebay dam approximately 25 feet from left abutment and two feet below crest (April, 1979).

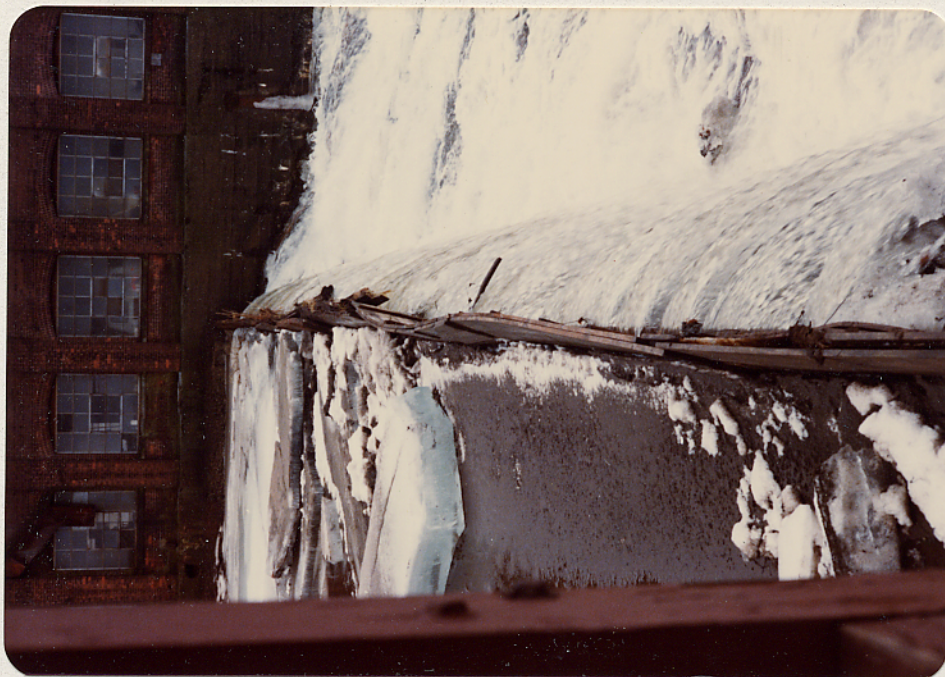
PHOTO 13 - Forebay dam in winter. Note build-up of ice behind flashboards (January, 1979).

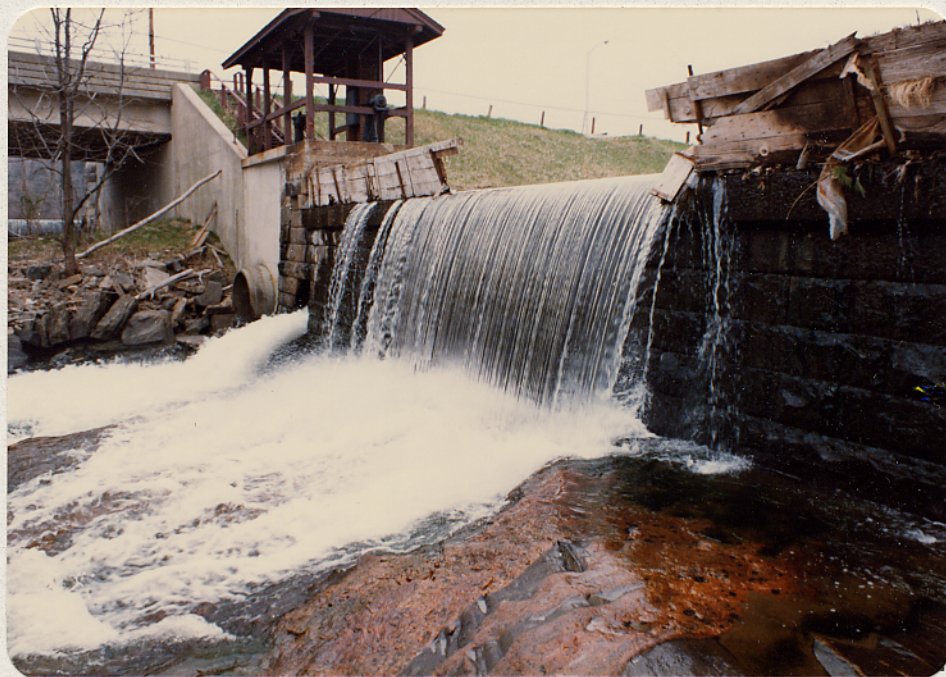
PHOTO 14 - Close-up of downstream face of forebay dam. Note broken flashboards, and natural ground downstream of right abutment and under Route 179 bridge (April, 1979).
